NAT Case study – Measurement campaign

Acoutrain Final Conference
Maria Starnberg, DB

Acoutrain measurement campaign

Measurement EMU “NAT” Jan 2014, Valenciennes, by SNCF

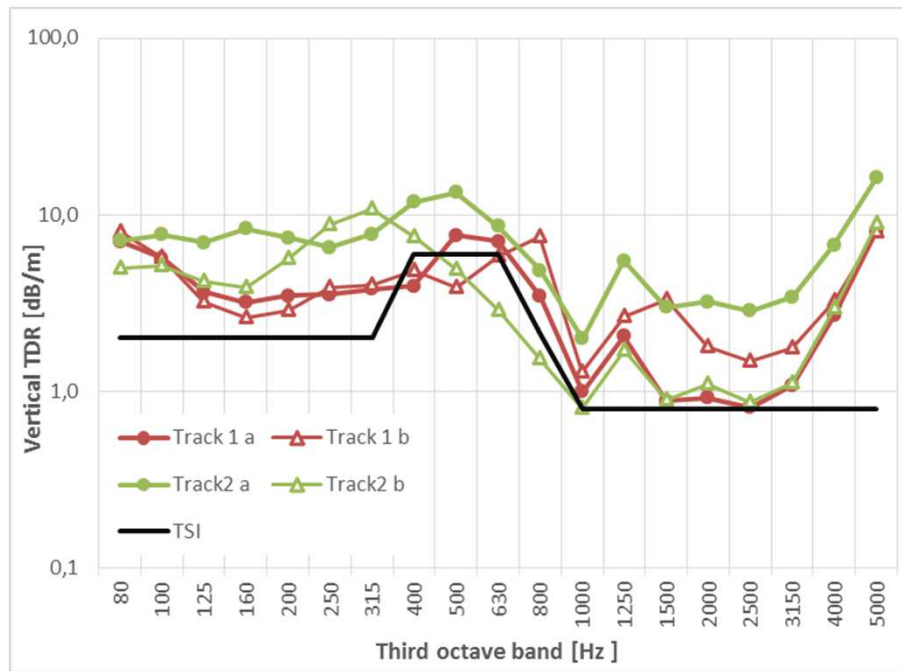
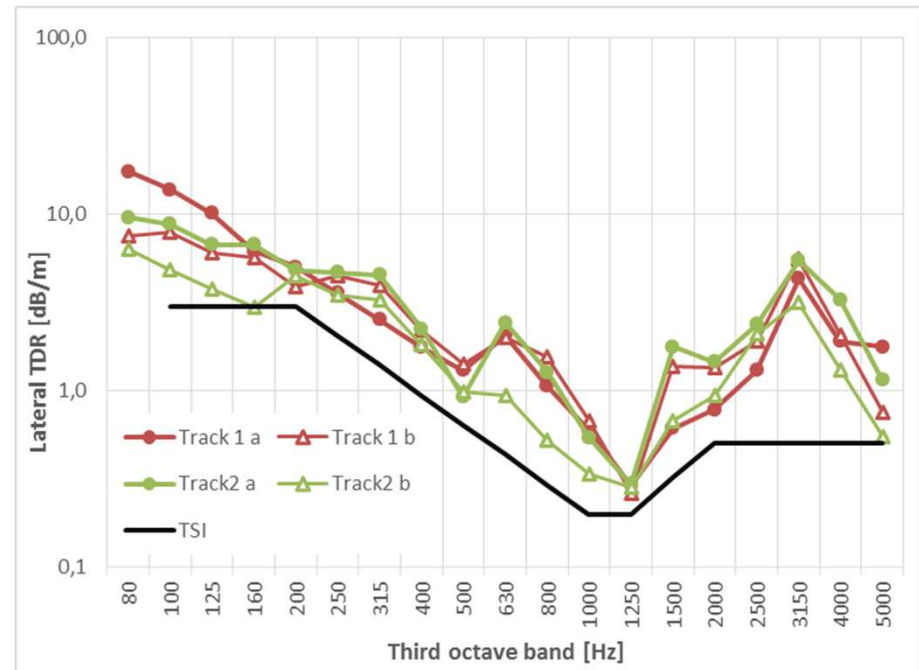
TDR measurement results

The characterisation of the test site

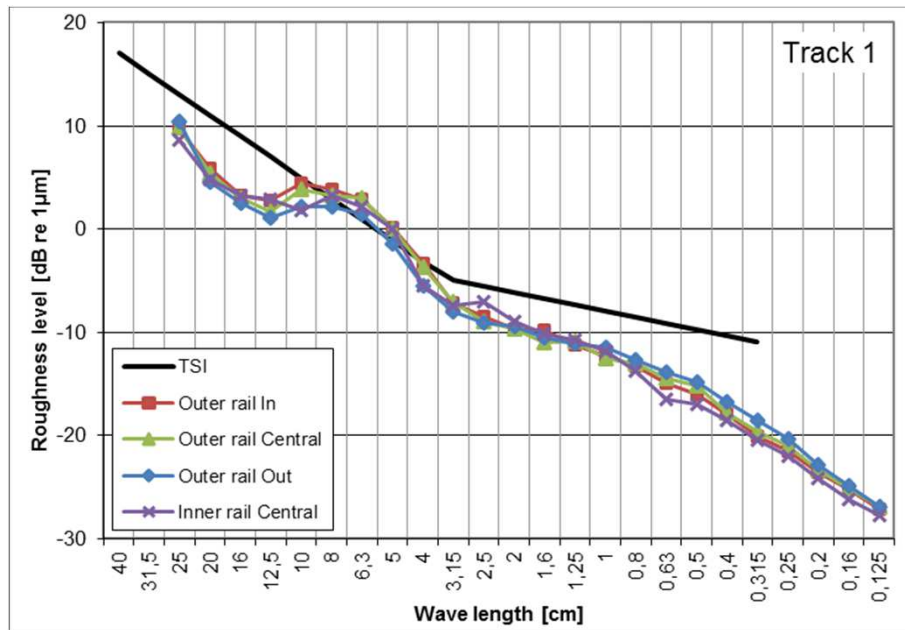
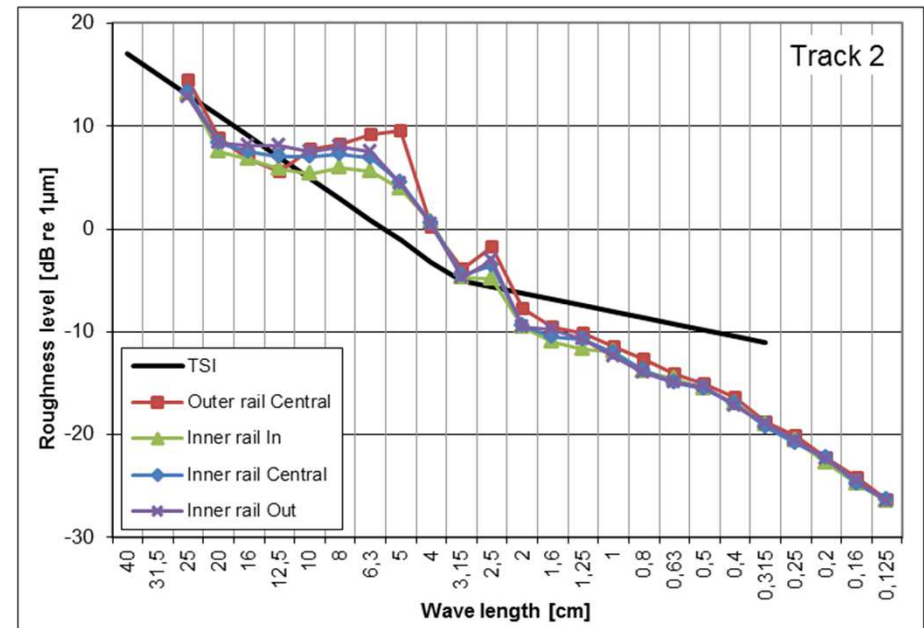
Rail roughness measurement results

The characterisation of the test site
